Application: 1999-2005 Ford F-250, F-350, F-450, F-550 Super Duty 4-Wheel Drive Trucks

Ford Super Duty 4WD Wheel Hub Assembly

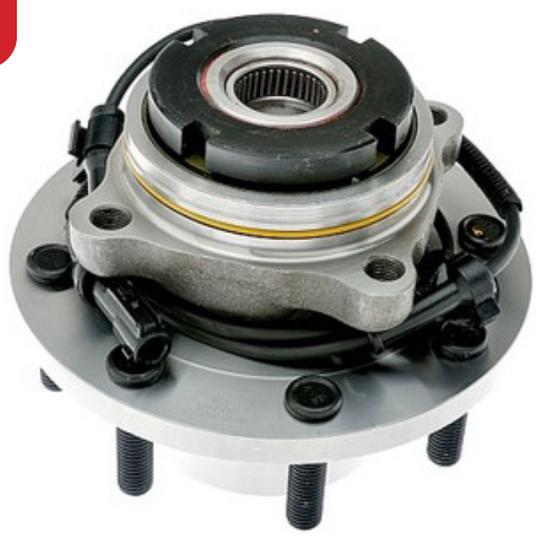
- ▶ **Symptoms:**
Wheel Bearing noise, loss of 4-wheel drive operation, ABS system malfunction, illuminated ABS warning light, or premature failure of the hub assembly.
- ▶ **Causes:**
Improper Needle Bearing lubrication, O-ring damage during install, or removal of the replacement ABS Sensor.
- ▶ **Solutions:**
Proper lubrication and installation of a replacement hub assembly.

Tip 1.) Needle Bearing Lubrication:
It is necessary to apply a liberal amount of high-temperature wheel bearing grease to the inner needle bearing of the replacement hub bearing assembly prior to installation, use only premium high-temperature wheel bearing grease. Failure to properly lubricate the inner needle bearing during installation can result in wheel bearing noise and premature failure of the hub bearing assembly.

Tip 2.) O-ring Seal:
Be sure not to damage the O-ring seal located near the base of the mounting flange on the hub assembly. **NOTE:** This o-ring is usually yellow or yellow/black. Lightly grease this o-ring just prior to installation. This will help it slide into the axle housing during installation. As you slide the hub assembly into the axle housing, care should be taken to make sure the o-ring stays safely in its groove. If the o-ring is damaged, this will cause a vacuum leak and loss of 4-wheel drive operation on these trucks.

Tip 3.) ABS Wheel Speed Sensor Harness:
WARNING do not remove the ABS wheel speed sensor harness from the replacement hub bearing assembly during installation. The ABS harness provided with a new replacement hub bearing assembly is specifically calibrated to this hub bearing assembly and must not be removed. Removing the sensor could cause a malfunction of the Anti-Lock Brake System and an illuminated ABS warning light.
